NAVAER 00-754-10

JULY 1957

approach

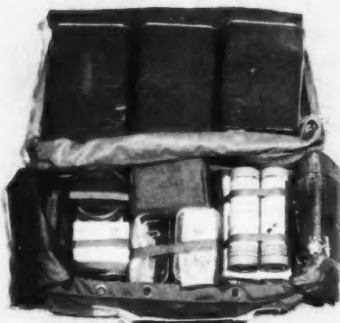
CONTENTS

(We plan to replace two of the cans of water with the new midsize para kit transceiver AN/URC-4 when they become available):

- 1 PK-2 liferaft container
- 3 quart cans of water
- 1 poncho
- 1 pocket signaling mirror
- 4 signals (night/day)
- 1 roll type first-aid kit
- 1 can sunburn ointment

Robert G. Baynes, PR1, had the original idea as far as we are able to determine. The items are all obtainable through supply.

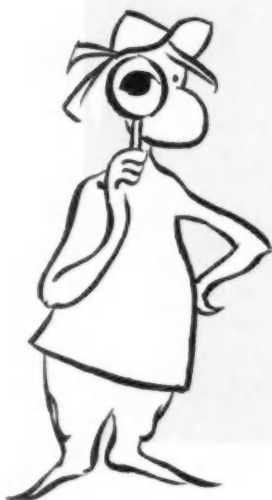
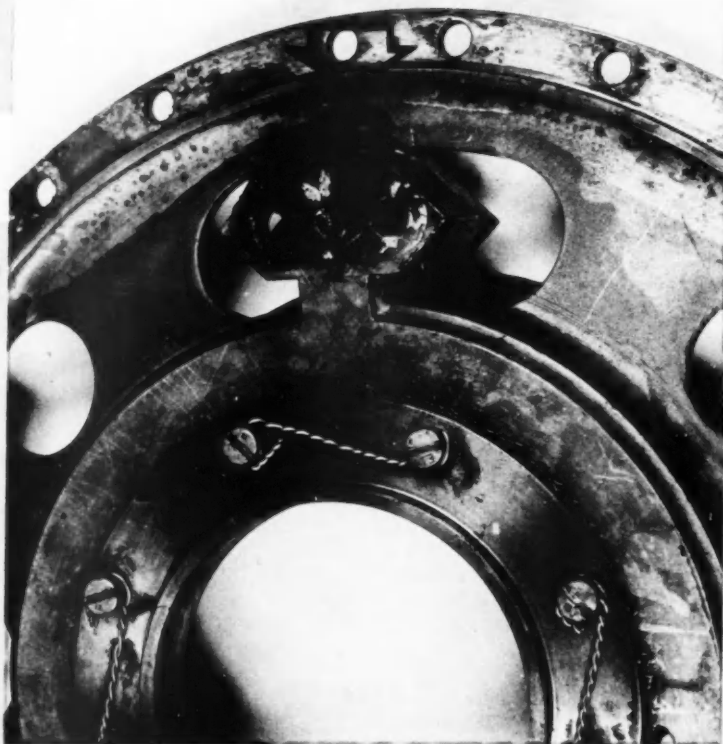
MURPHY—A J34-WE-34 engine failed in a portable test stand following "C" maintenance. The engine was sent to the manufacturer for inspection. The engine failure was caused by a restricted oil supply to No. 3 bearing.

The reason for the restricted oil supply was improper installation of the gasket between No. 3 bearing oil outlet tube and the No. 3 bearing housing boss. The improper installation of the gasket resulted in loss of oil pressure. Inspection of the oil tube housing joint following bearing housing installation would have revealed the improperly assembled gasket. (See photo)
